# Environmental Impact Statement

Harquahala Valley Watershed

Maricopa and Yuma Counties, Arizona

March, 1977

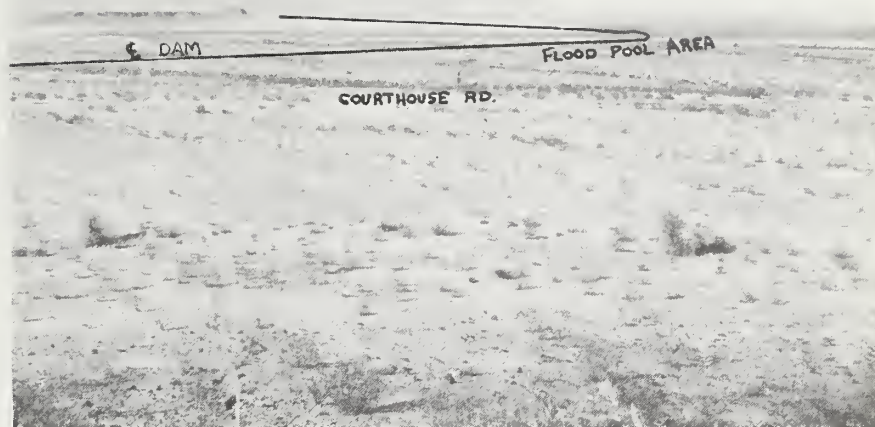
Figure P1. Looking north toward Burnt Mountain showing alignment of Saddleback F.R.S.

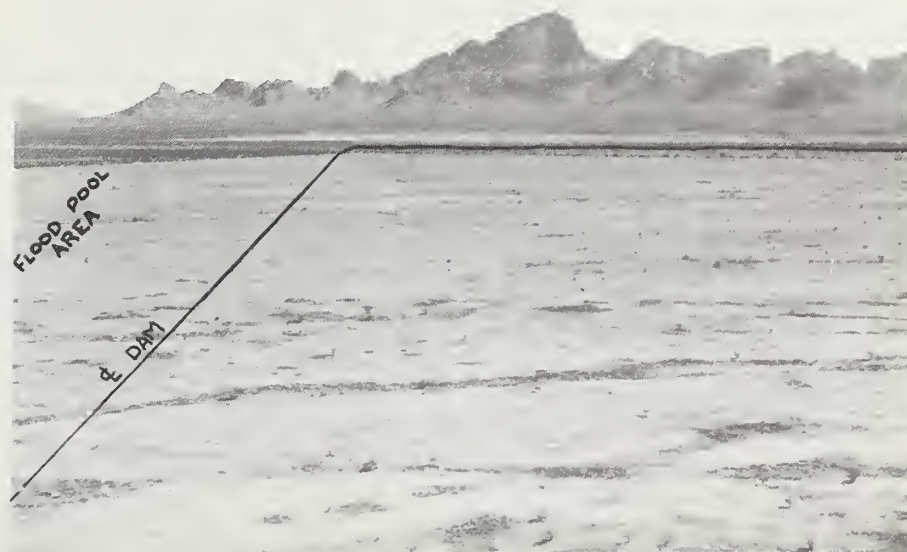
Figure P2. Alignment of Saddleback F.R.S. looking southeast from andesite knoll, Section 27, T2N, R8W. Saddleback Mountain in background.

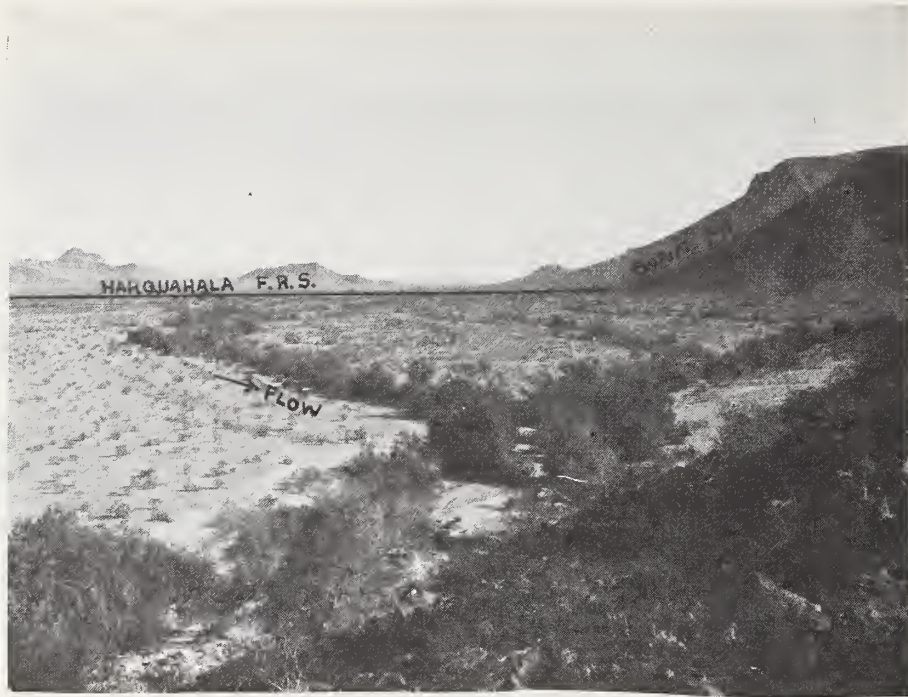
Figure P7. Looking north showing location of Harquahala F.R.S. and the natural wash section of Harquahala Floodway.

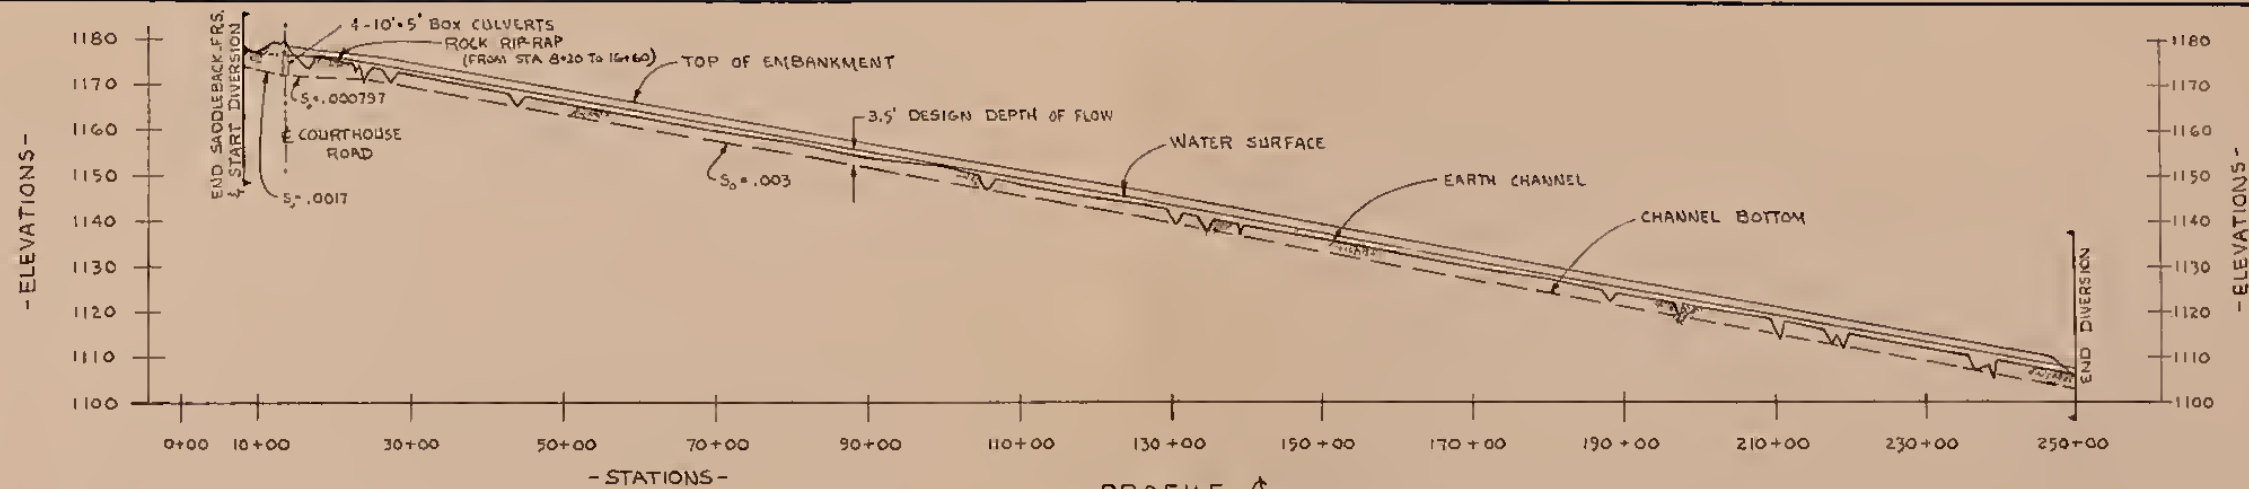
PROFILE  $\phi$   
SADDLEBACK DIVERSION

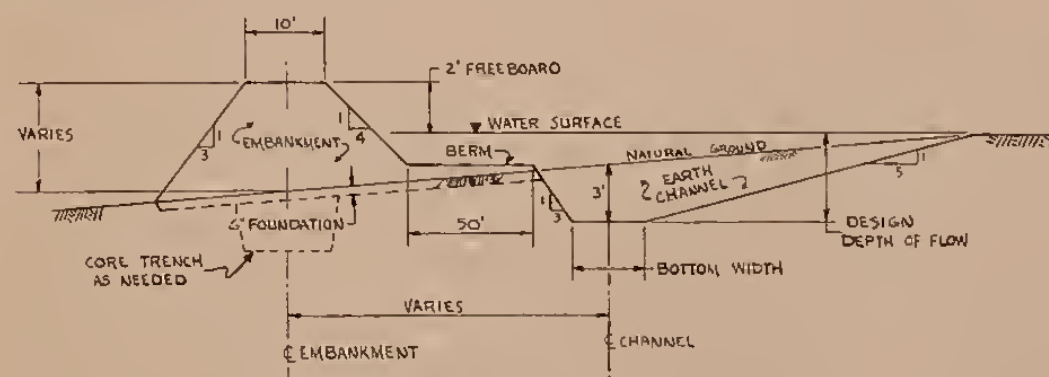
CROSS-SECTION  
CHANNEL & EMBANKMENT

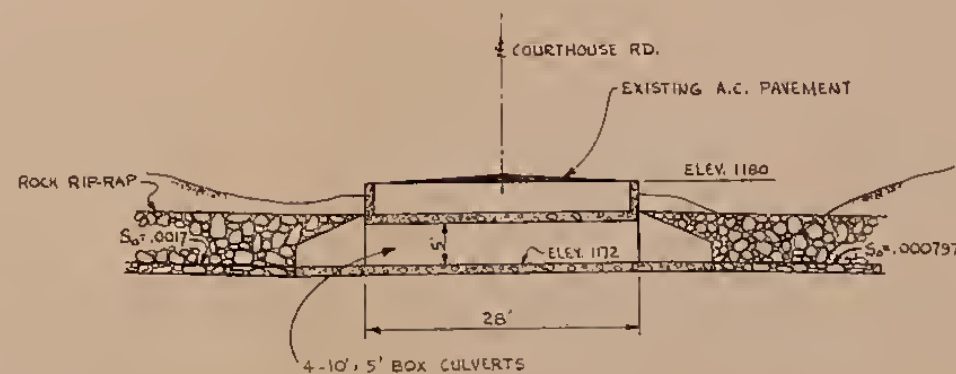
CROSS-SECTION  
COURTHOUSE ROAD

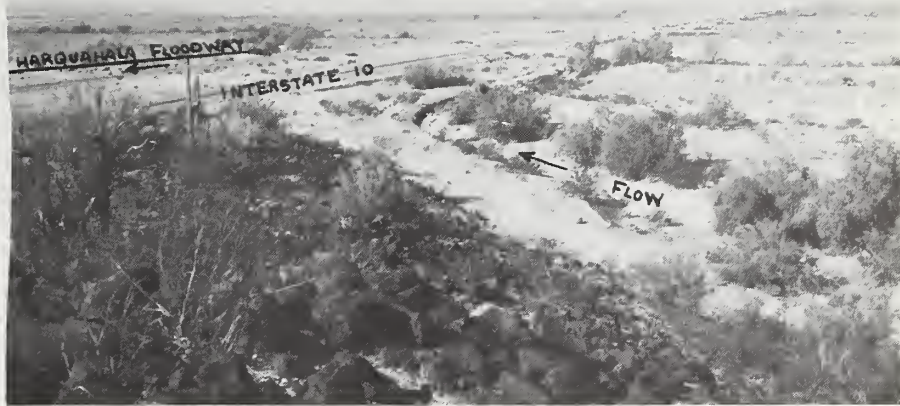
Figure P9. Looking southwest showing where Harquahala Floodway will cross Interstate 10.

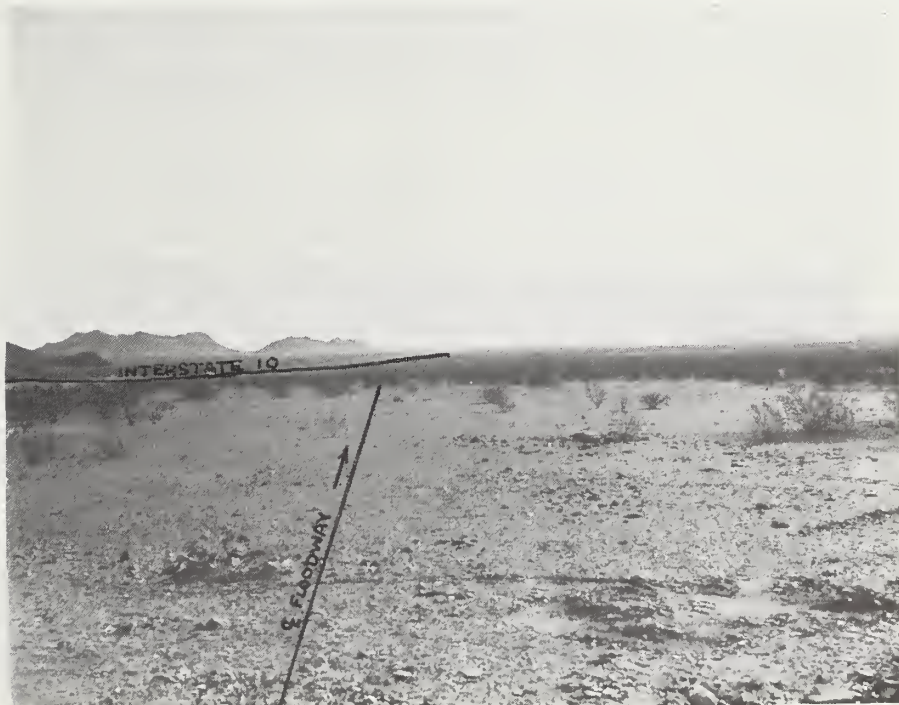
Figure P10. Looking east showing alignment of Harquahala Floodway Reach 4.

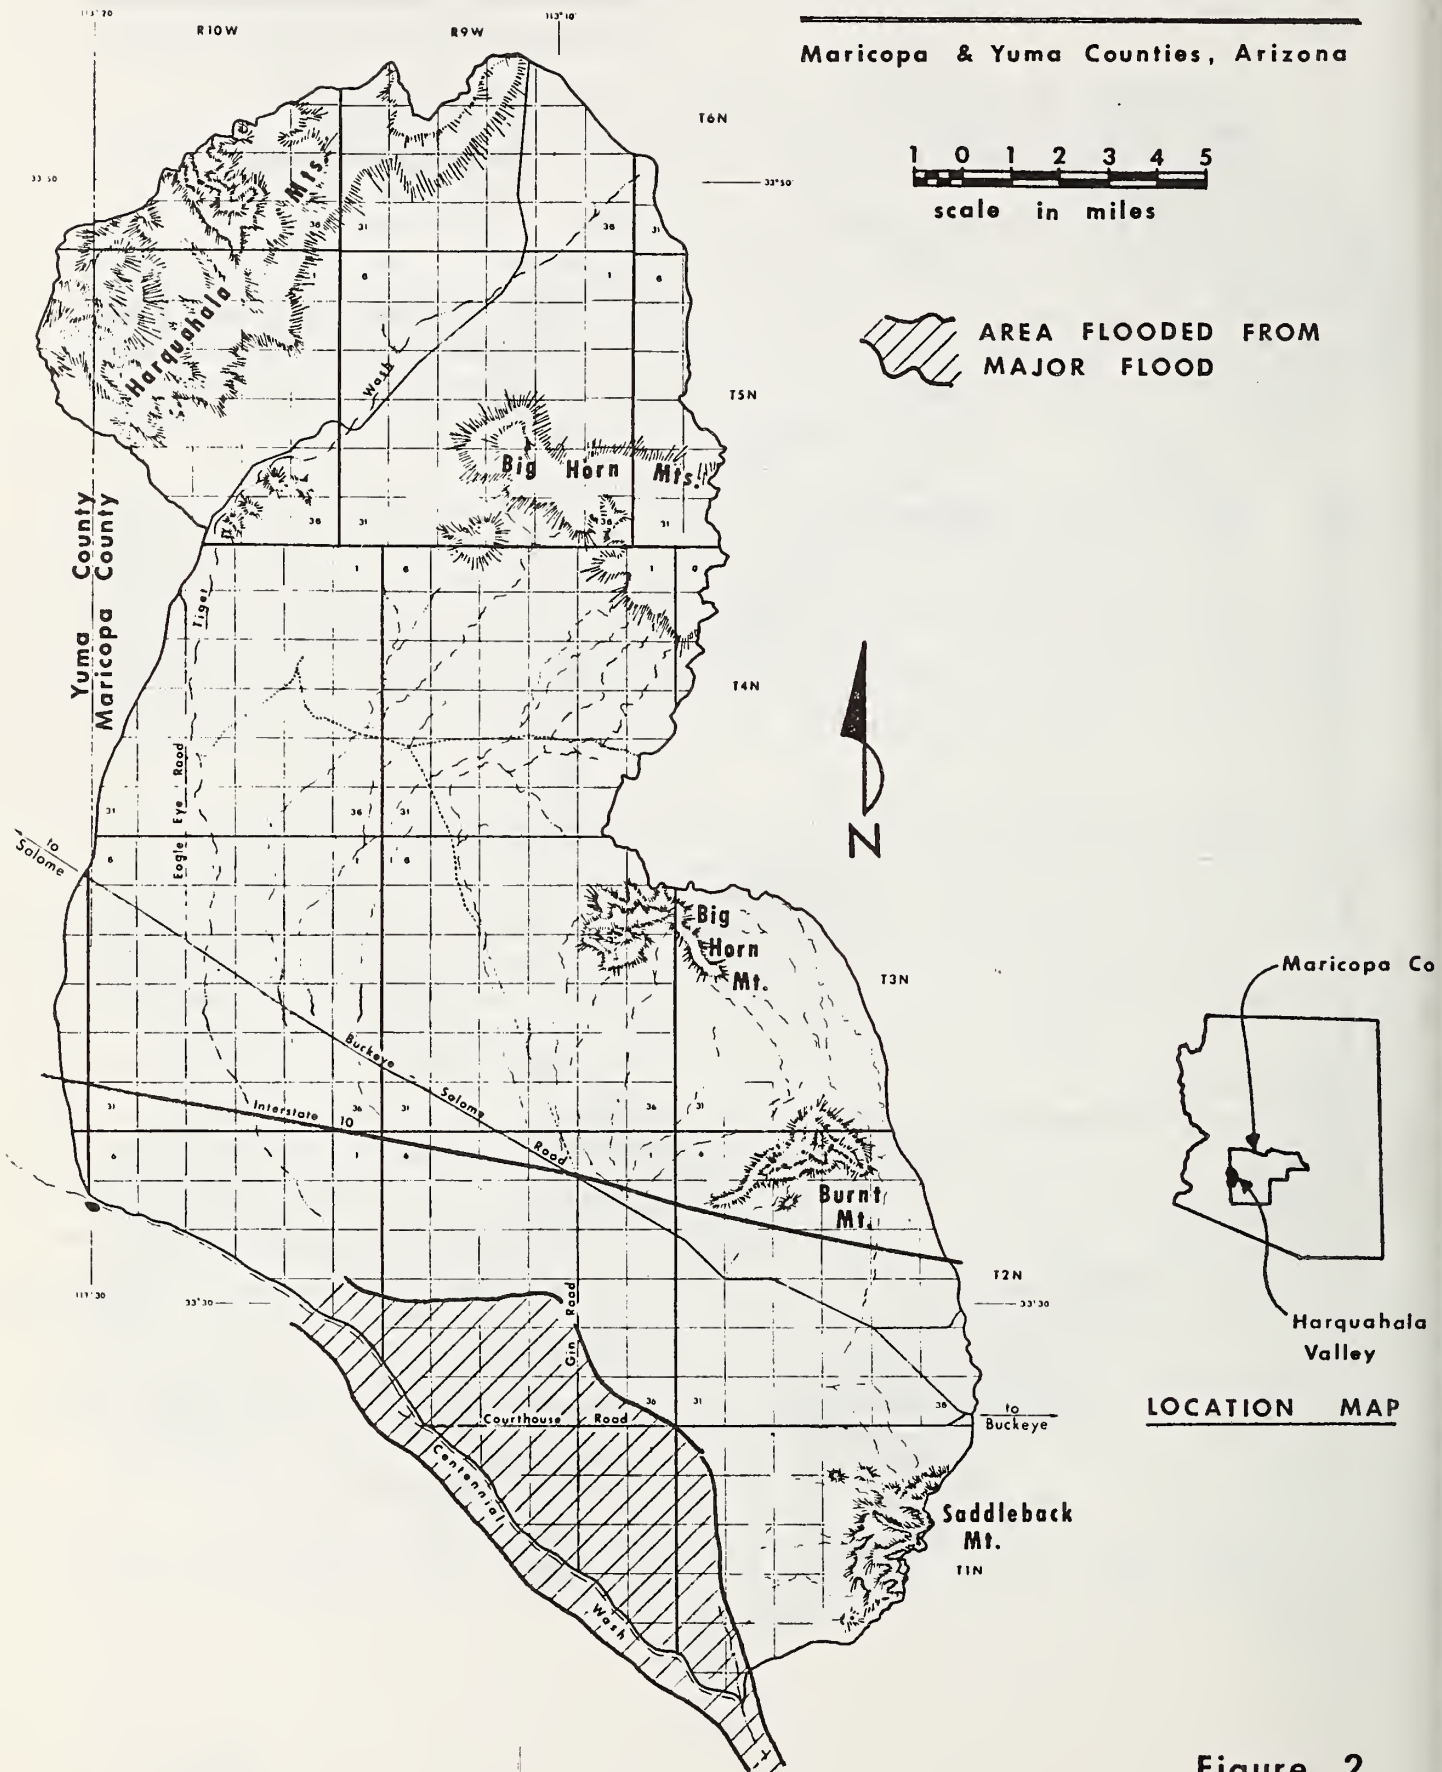
Figure 2

FLOOD OF AUGUST 26, 1964

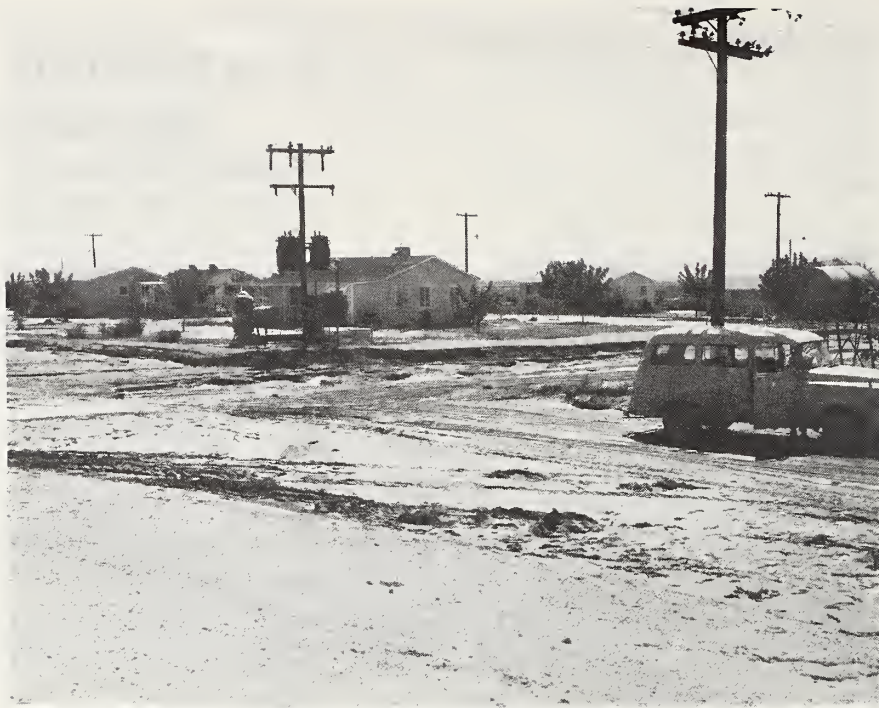
Figure P15. Flood and sediment damages in Harquahala Valley from storm of August 26-27, 1964.

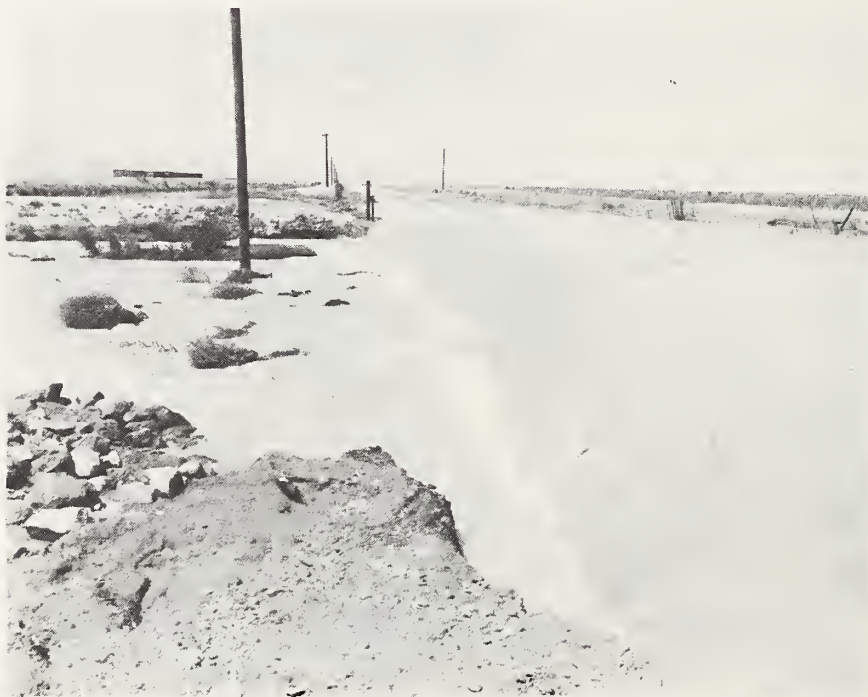
Figure P16. Floodwaters from the storm of August 26-27, 1964. Looking west along Courthouse Road.

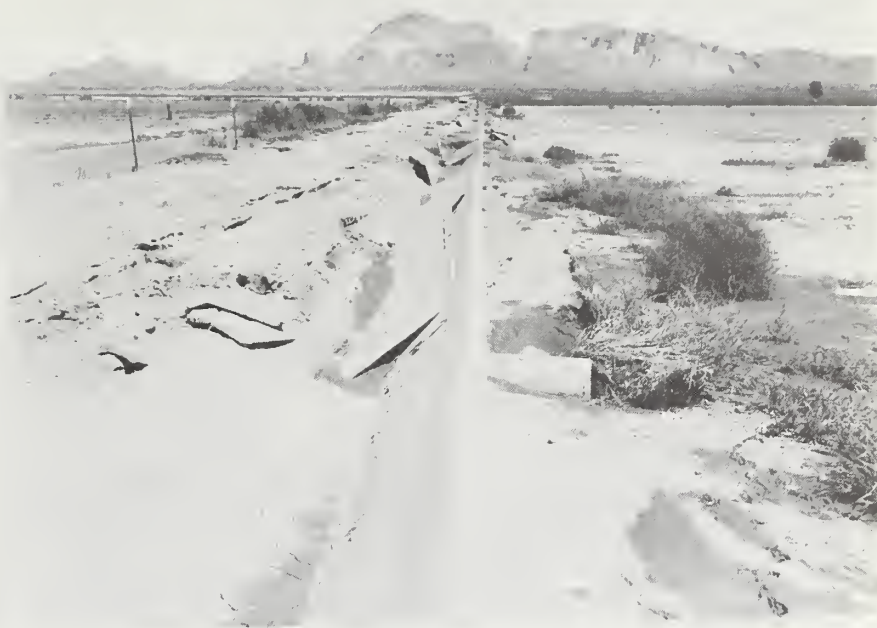
Figure P17. Irrigation canal washed out by the flood of August 26-27, 1964. Looking east along mid-section line, Section 7, T1N,R8W.

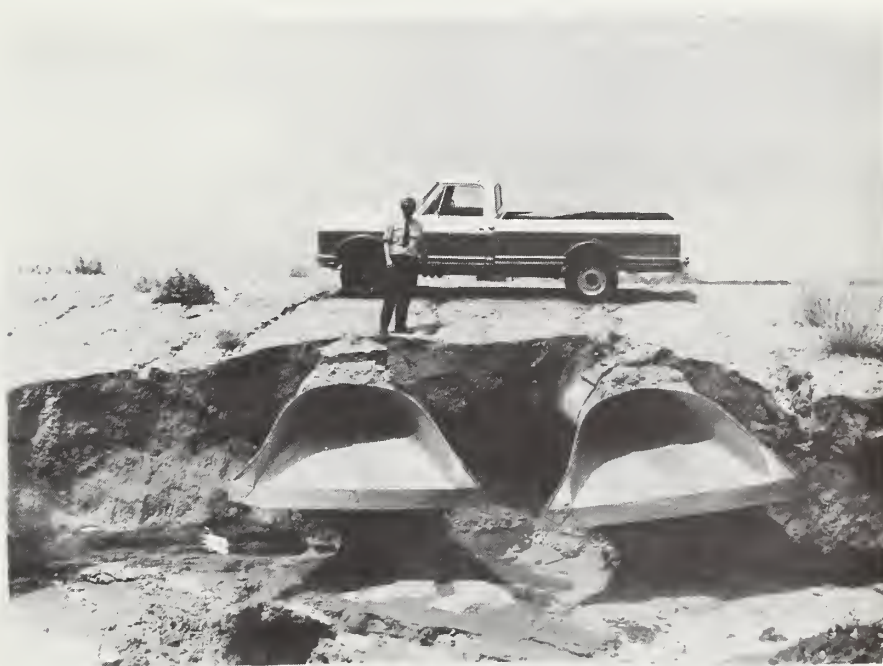
Figure P18. Flood damage to Interstate 10 culverts from storm of August 1971.

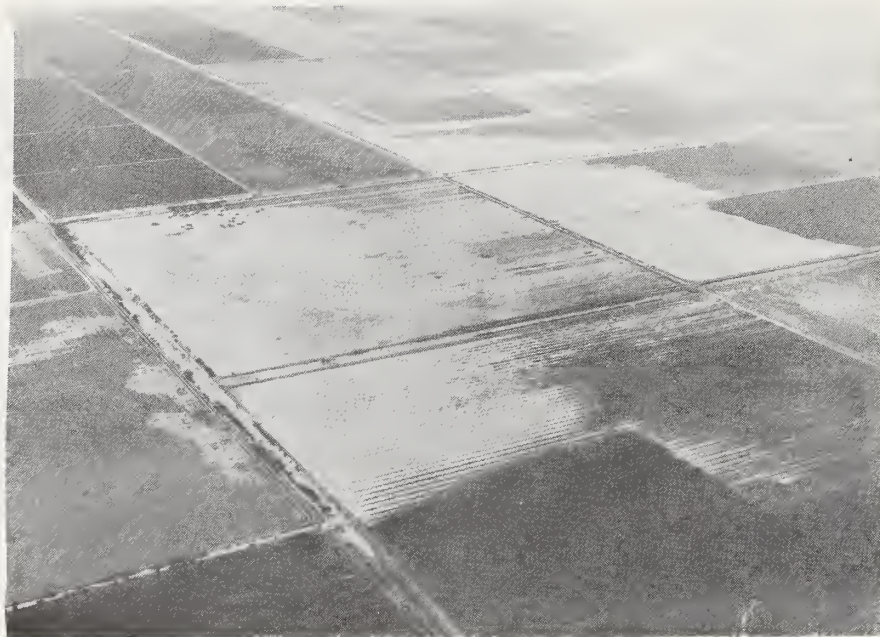
Figure P19. Looking northwest across irrigated lands of Harquahala Valley showing floodwaters from storm of August 1971.

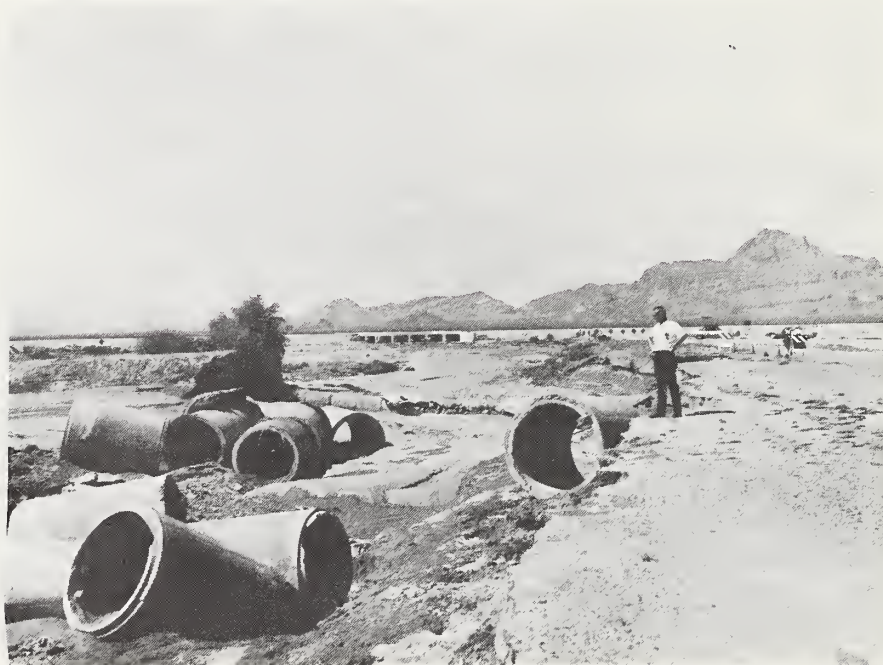
Figure P20. Flood damage to pavement and irrigation pipeline washed out from storm of August 1971. Looking north along Gin Road toward Interstate 10.

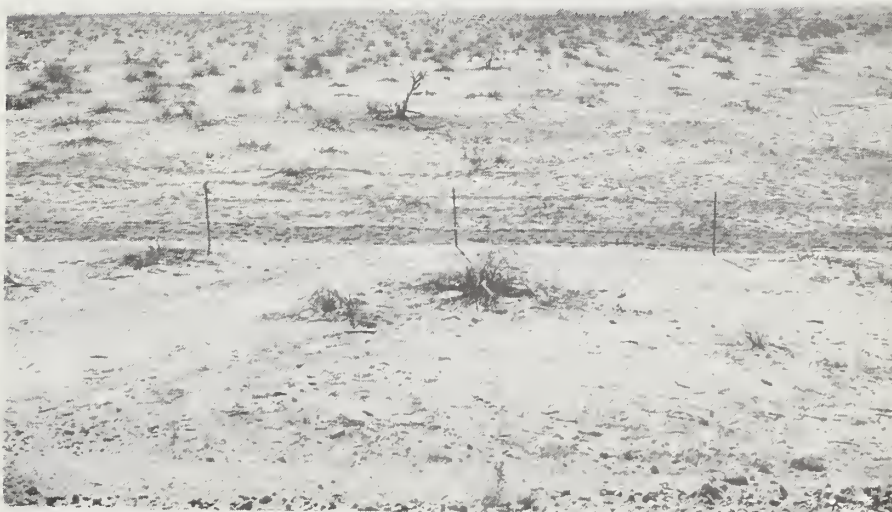
Figure P24. Dead creosote bush downstream of Interstate 10 in Harquahala Valley.

Impacts on vegetation from reduced water supply will occur downstream from each structure. The existence of mesquite, ironwood, paloverde and acacia trees predominantly along washes indicates their pseudoriparian nature and partial dependence on periodic flows to provide moisture. Losses can be expected to these tree species as well as to the dominant creosotebush. In some areas, trees may be completely lost whereas others will be only slightly stressed. (See Figures P21 and P22.) Areas with coarse grained soils will probably not be affected as much as those with fine grained soils. Creosotebush loss has occurred downstream from both Interstate 10 and Allison Tank. Similar losses will probably occur downstream from the project structures. It is estimated that 1,530 acres of land dominated by creosotebush will be affected. Losses will approach 100 percent immediately below the structures with some effects occurring up to 1/4 mile downstream. (See Figures P23 and P24.)

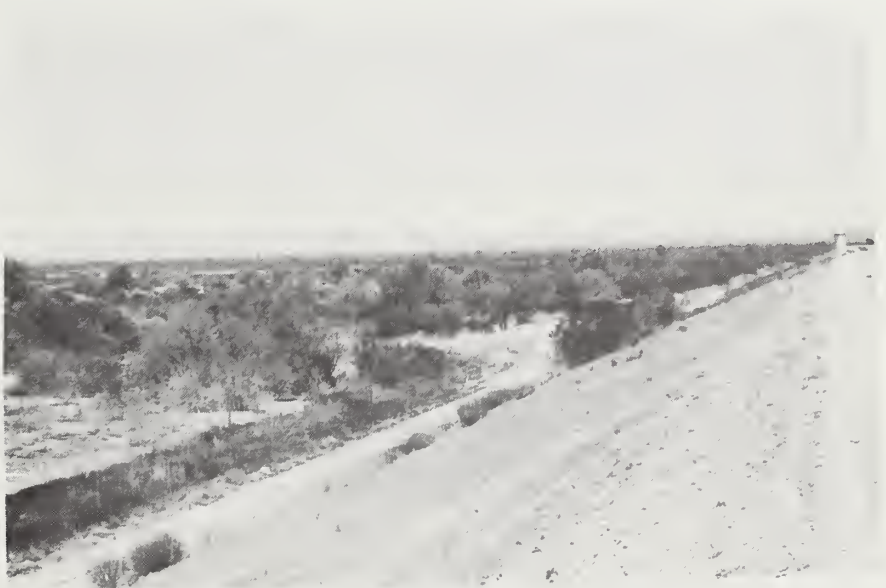
Figure P26. Growth in the flood pool of McMicken Dam. Looking north from top of dam.

temporary storage increases availability of soil moisture. This will be particularly true of pseudoriparian tree species which are important to wildlife. At other areas within the flood pool where temporary storage is infrequent, existing vegetation will be somewhat more vigorous with little change in plant species composition. Siltation and prolonged inundation of some areas may periodically destroy, retard growth, or cause a change in plant species. It is not anticipated that any reduction will be significant or frequent. Evaluation of other flood control structures in southern Arizona shows a general increase in woody growth in reservoir and diversion areas. (See Figures P25 and P26.)

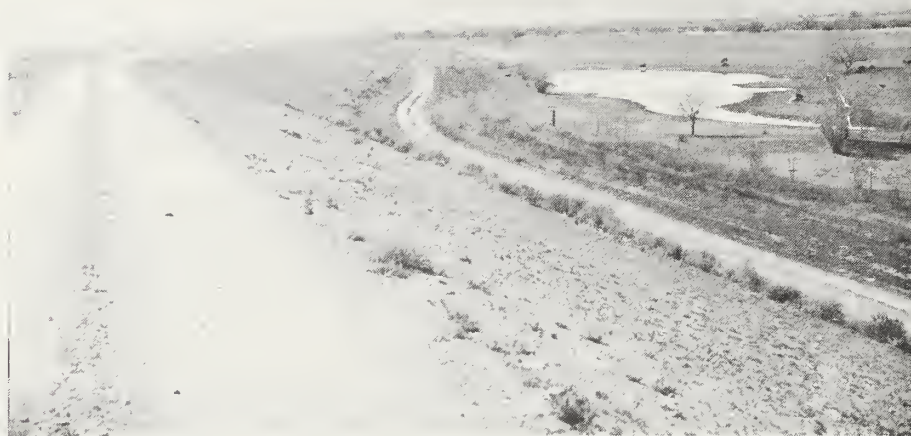
Figure P29. Typical floodwater retarding dam  
(McMicken Dam - Corps of Engineers).

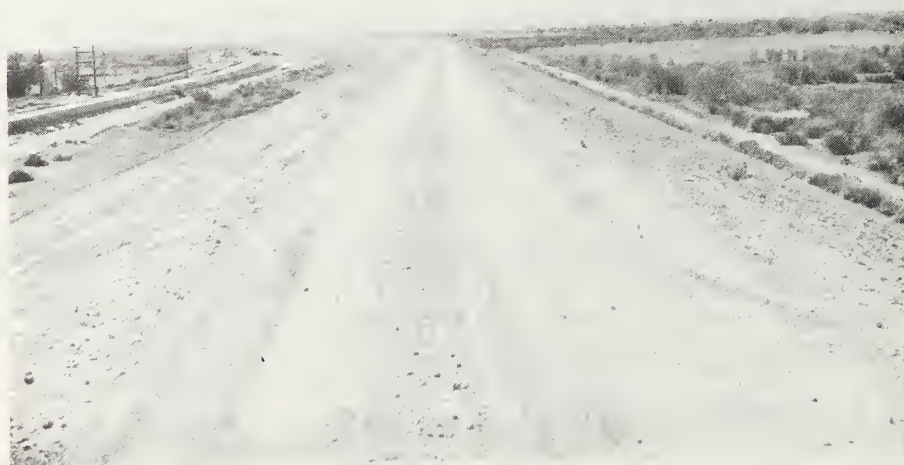
Figure P30. Typical floodwater retarding dam  
showing canal on the downstream side of embank-  
ment. (McMicken Dam - Corps of Engineers.)
